Road Safety Audit – Pewsey

Stage: 1

Location: Wilcot Road and Woodborough Road, Pewsey, Wiltshire

Site: Proposed new vehicle access and footways

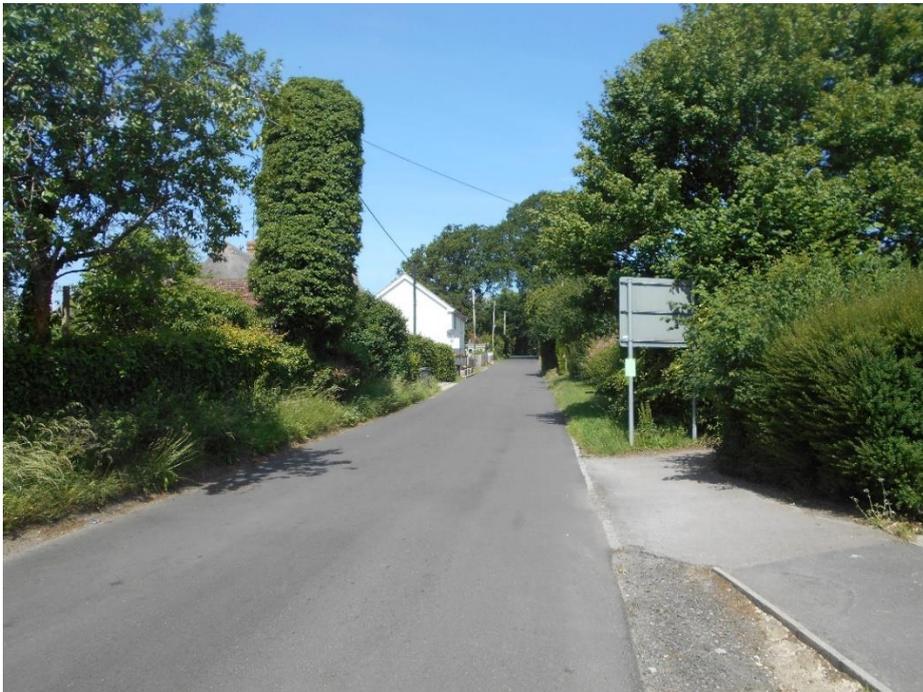
Looking north-west on Wilcot Road. A short length of solid footway is proposed on the right side of the road, replacing the verge visible

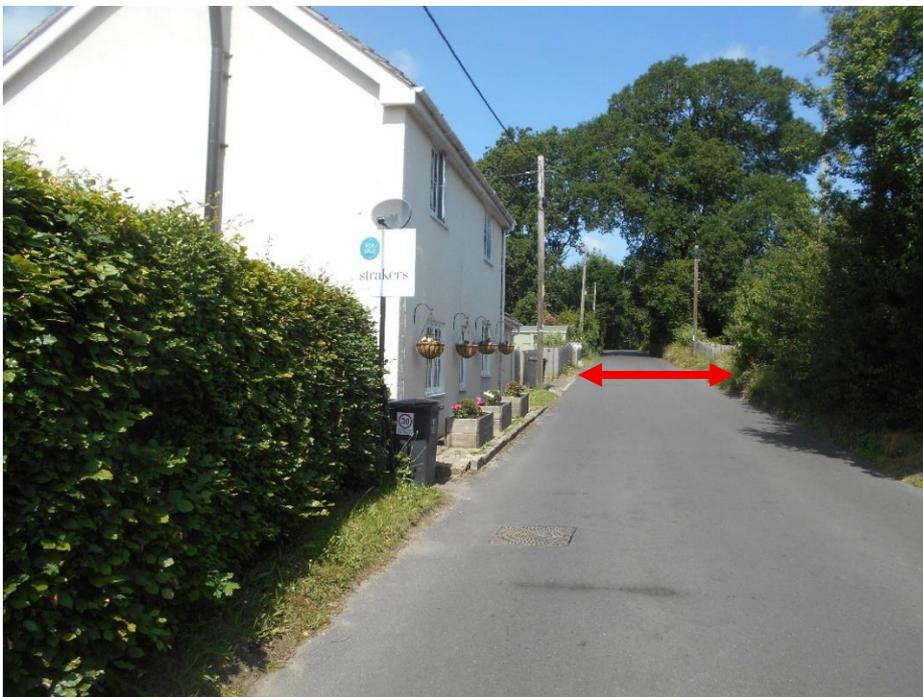
Looking north-west on Wilcot Road, showing the approximate position of the informal pedestrian crossing. At this point the solid footway on the right will terminate, and a solid build-out will be constructed on the left, to provide a platform for crossing pedestrians. A 'soft' or 'false' footway will be continued north-westward on the left side, from this point to the new vehicle entrance

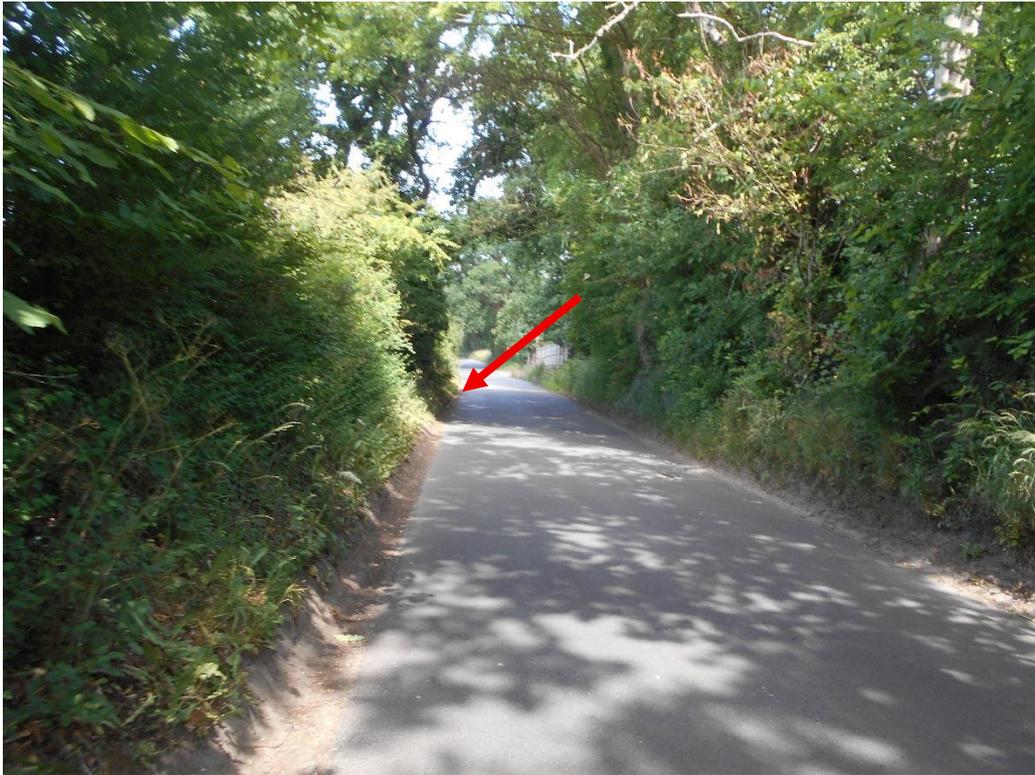
Looking north-west on Wilcot Road. The approximate location of the new vehicle entrance is arrowed

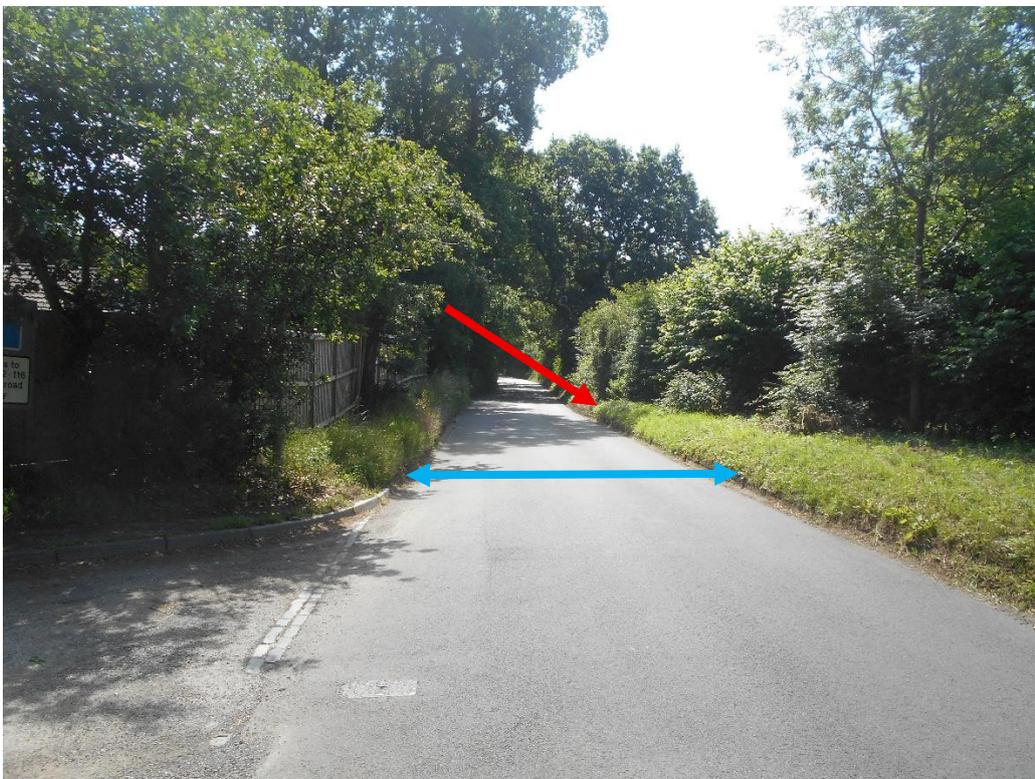
Looking south-east on Wilcot Road. The approximate location of the new vehicle entrance is arrowed red, and the approximate position of the informal pedestrian crossing arrowed blue. A short length of footway will be constructed on the right side between the 2 arrows

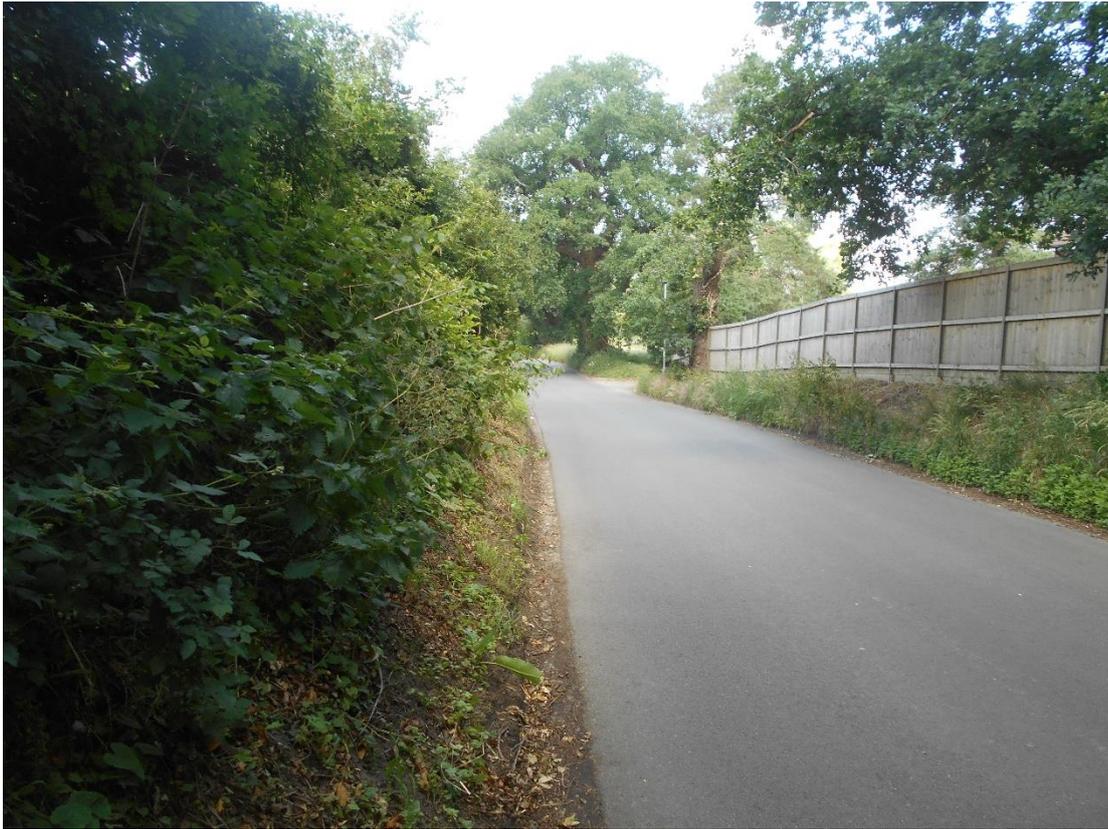
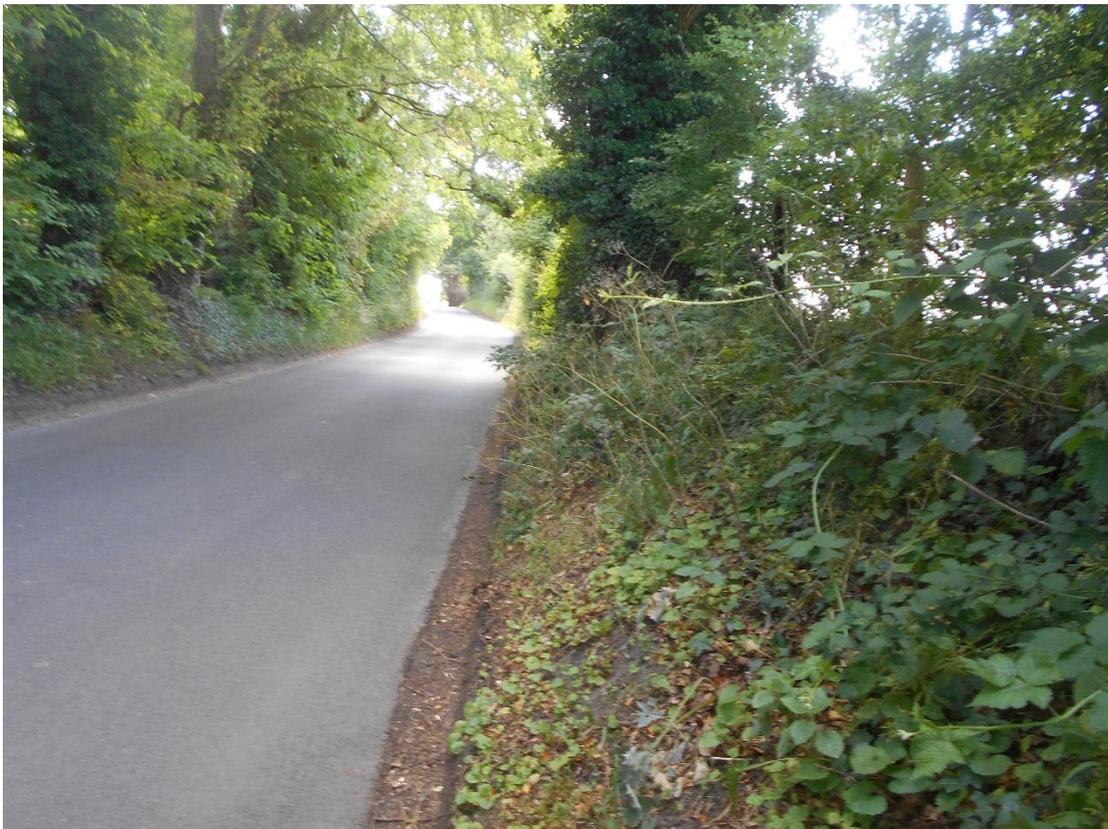
Approximate views to left and right for a driver exiting the new access. Views to the left will be improved by removal of vegetation to construct the junction and footway

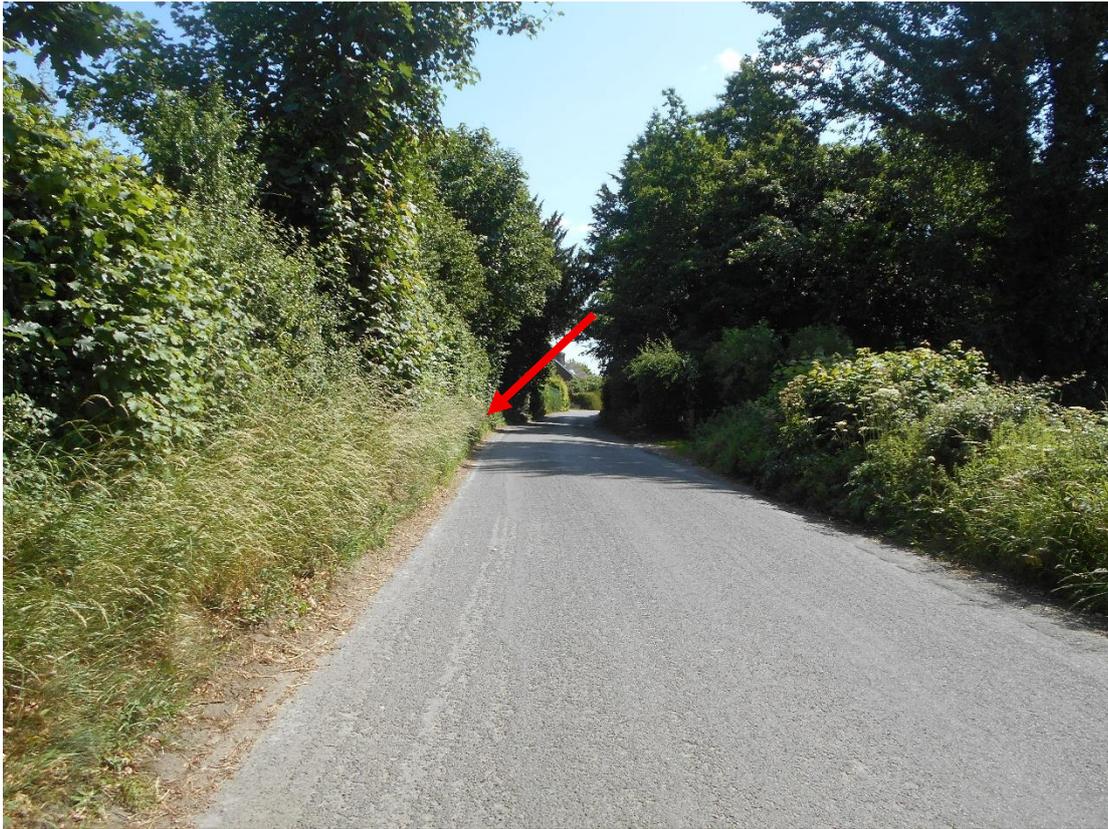
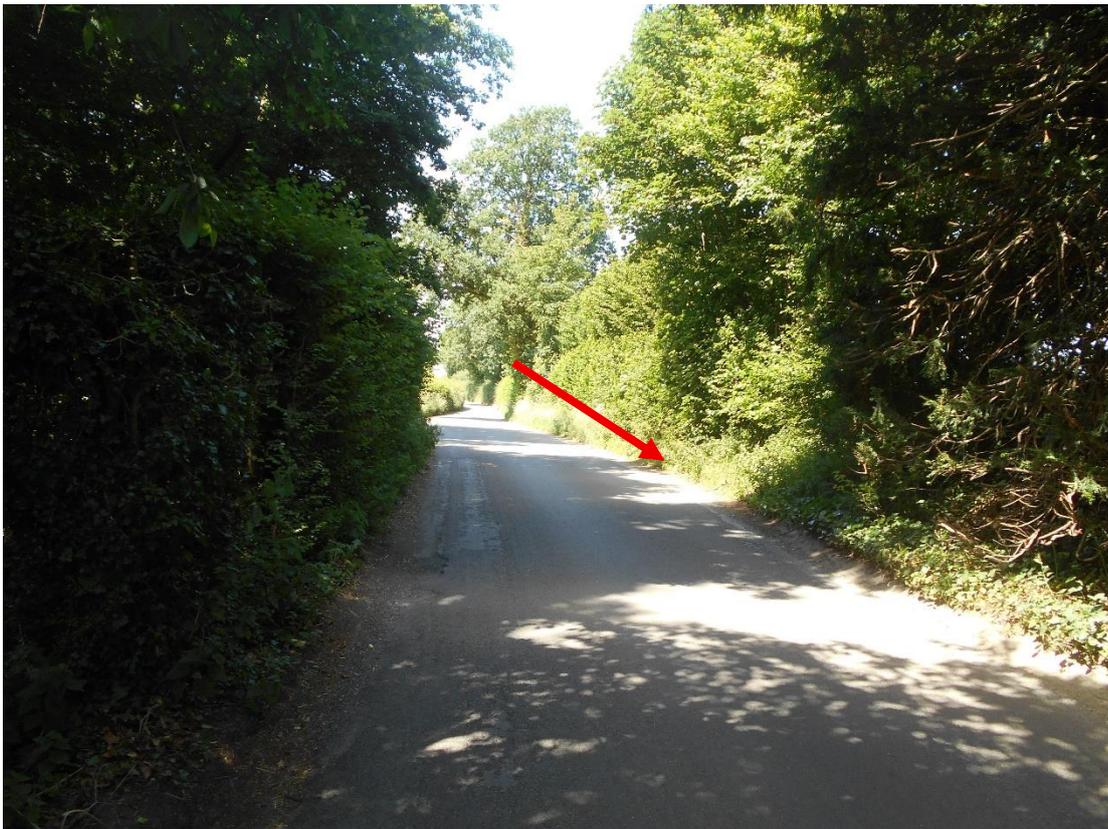
Views looking east (top) and west on Woodborough Road, showing approximate location of pedestrian/cycle access arrowed

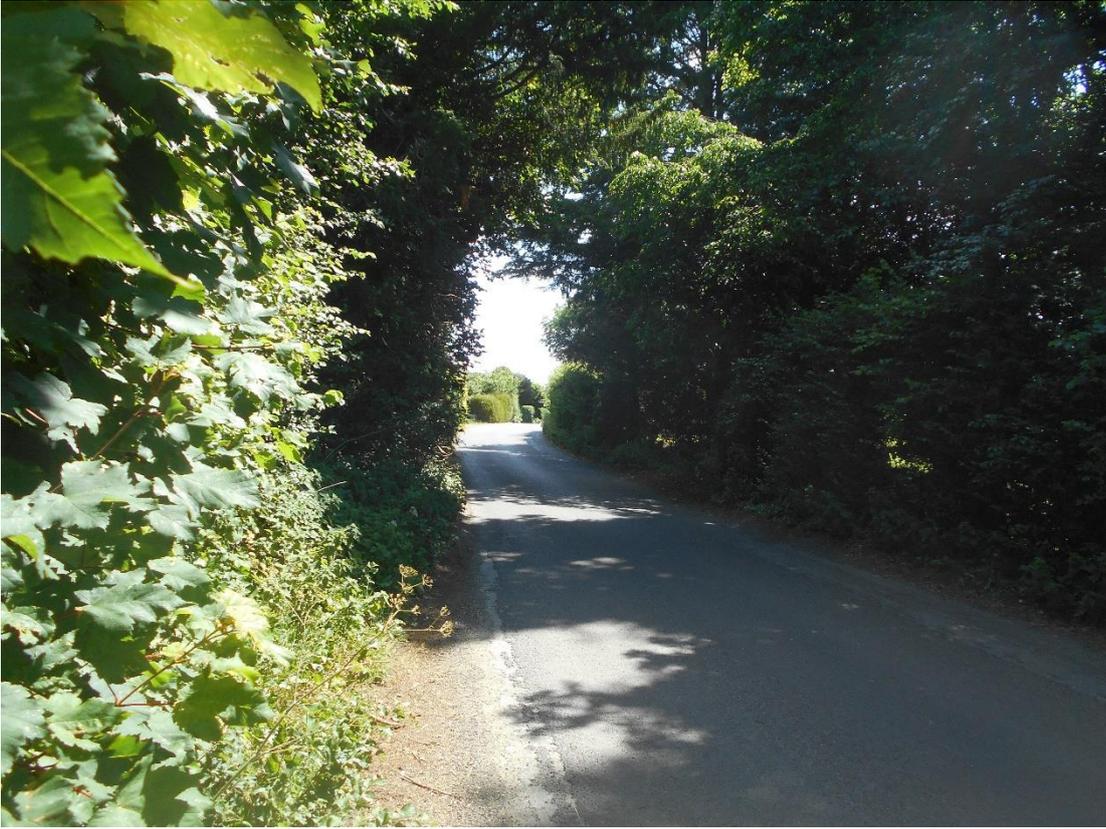
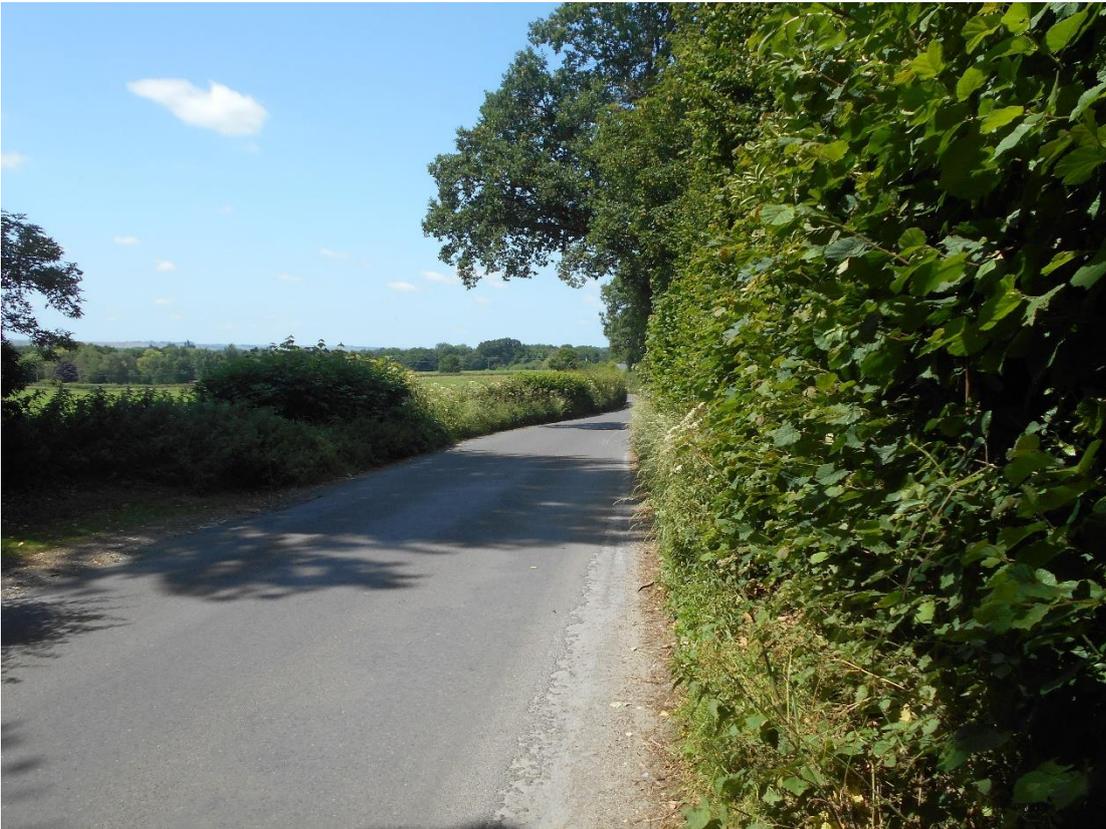
Views to left and right from the Woodborough Road access

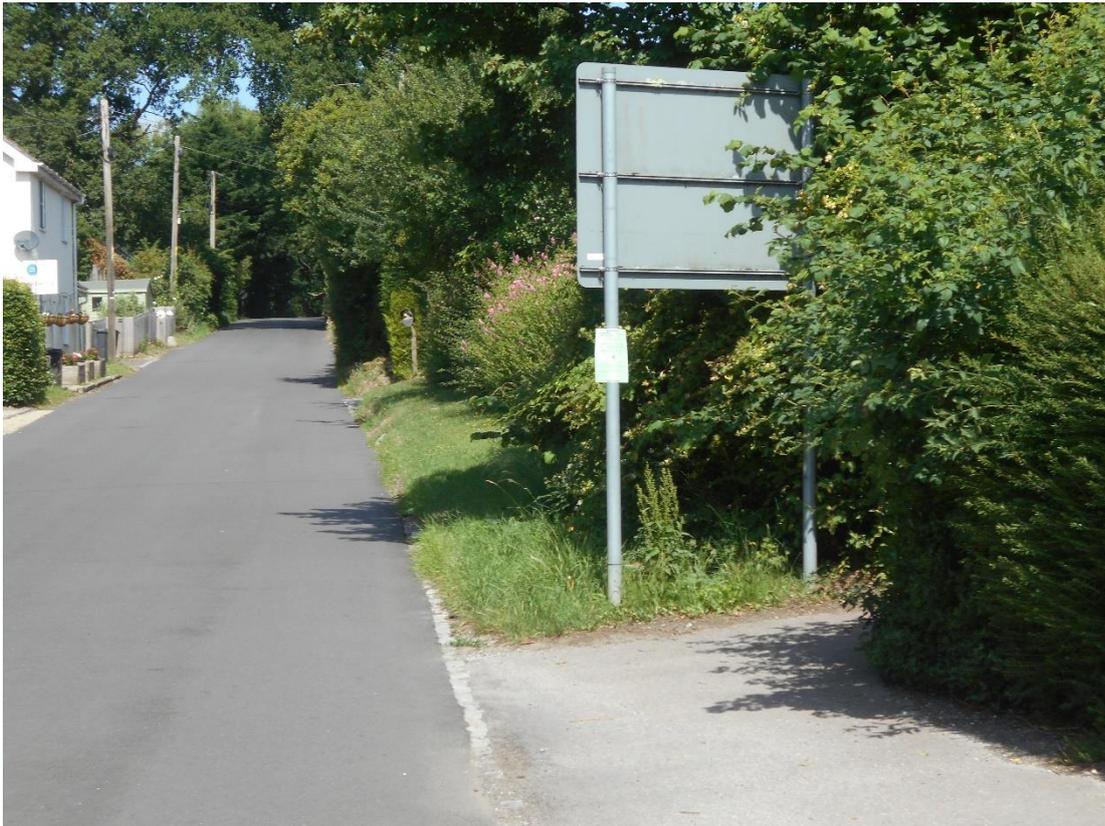
2.1 Problem

Location – Existing direction sign at east end of new footway

Summary – Risk of footway obstruction

It is proposed to raise the sign height to provide head clearance, however one of the posts supporting the sign will obstruct the footway

Recommendation – Relocate signposts so they do not obstruct the footway

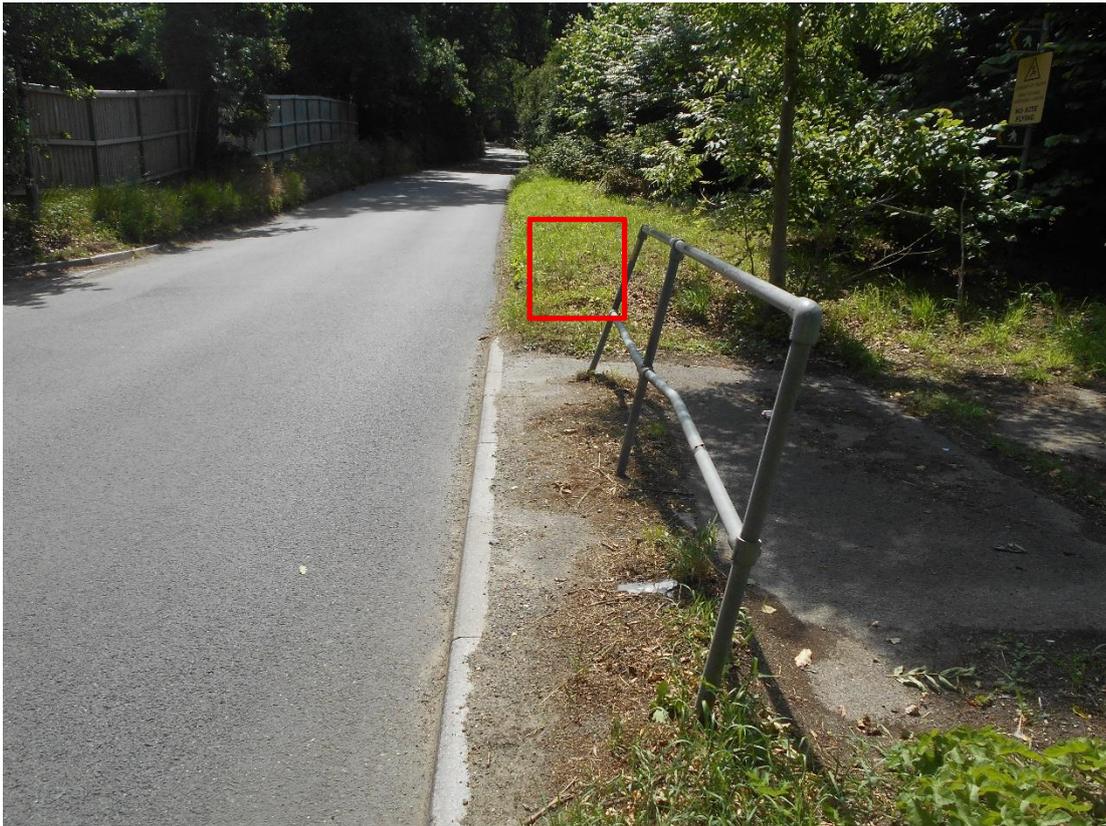
2.6 Problem

Location – North west end of new footway adjacent to new vehicle access

Summary – Risk of vehicle/pedestrian collisions, or pedestrian slips/trips

There appears to be an existing pedestrian crossing desire line between the rugby club fields to the south-west and the sports fields to the north-east, so pedestrians using this route may wish to use the proposed new informal crossing. However, there is no proposal to link the new footway to the rugby club access, so pedestrians may walk in the carriageway or on the verge between the two

Recommendation – Extend the proposed footway a short distance to link with the existing hardstanding outside the rugby club gates (indicated in red above)

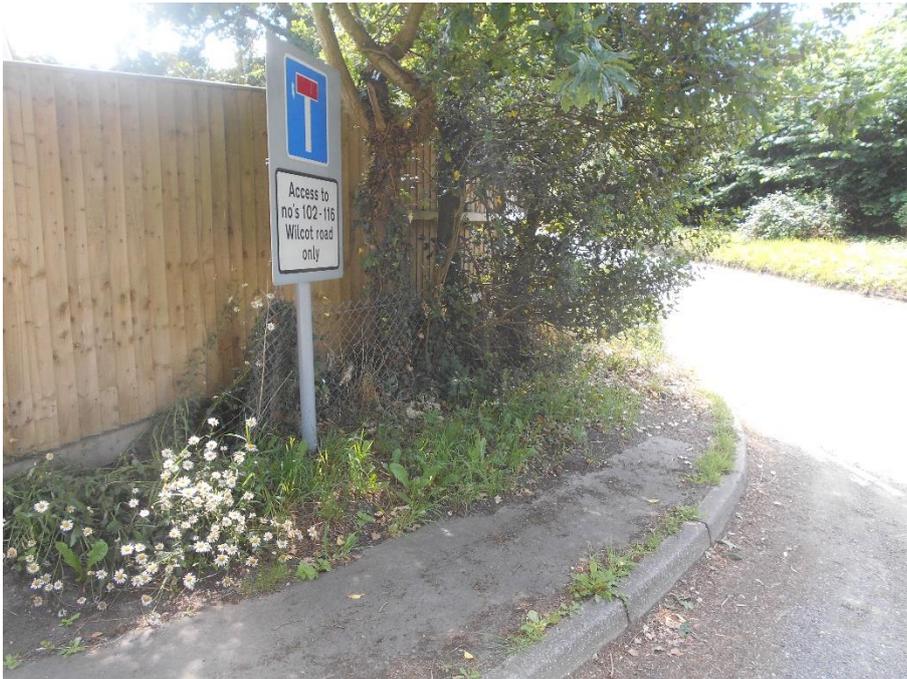
2.7 Problem

Location – Proposed informal crossing, Wilcot Road western end, north-east side

Summary – Risk of vehicle/pedestrian collisions

The north side footway is obstructed by vegetation both above and on the existing footway. Pedestrians are likely to walk in the carriageway to avoid these, increasing the risk that they will be struck by a passing vehicle

Existing vegetation obstructs the footway

Recommendation – Remove overhanging vegetation and side out the footway to provide a safe pedestrian route
